PLEA 2017 EDINBURGH

Restored store in Marqués de Larios St.

Rafael Assiego de Larriva¹, Carlos Cifuentes Álvarez², Fernando Gómez Jimenez², Gonzalo Gil Muñoz², Abel Porrás Illescas²

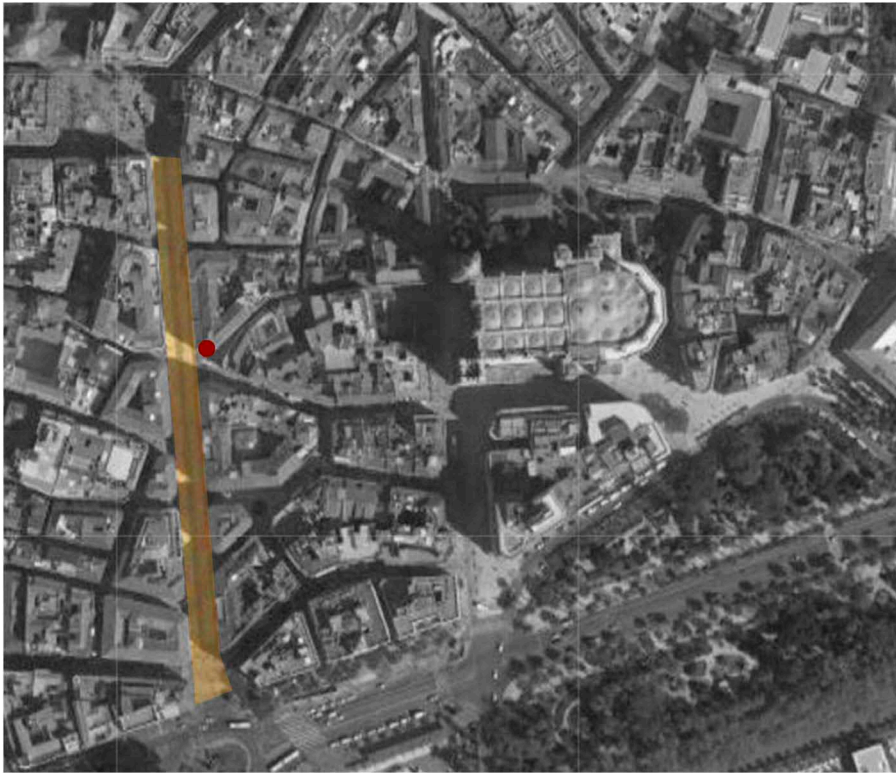
Figure 4. Situation Larios St. and building's investigation.

The investigation analyses a restoration work at a local shop located on 3 Marqués de Larios St., in Málaga, corner with Strachan and Salinas St. (see figure 4).

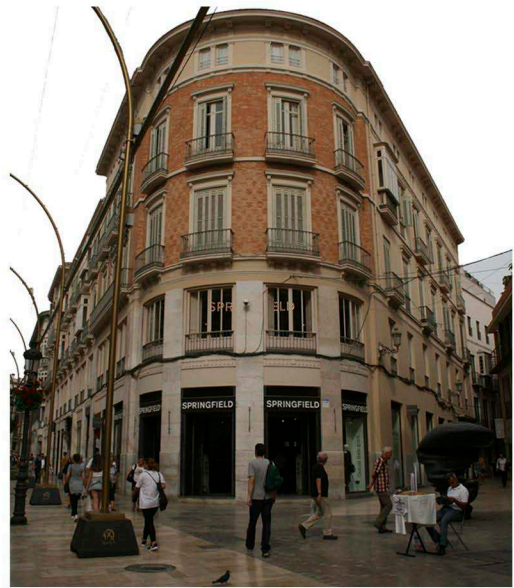
Figure 8. 3 Marqués de Larios St.

The building located on 3 Marqués de Larios St. (see figure 8), was built in 1889. It has a bourgeois style from the XIX century, designed by the architect Eduardo Strachan, who introduced the University of Chicago architecture style to the city of Málaga, with a similarity to a Hausman's Parisian boulevards.

The construction preserves its character of unity with the rest of the buildings in the same street, which were built by the same author.

It's distributed over four floors, including the street level as commercial business and an attic. The ground floor and the mezzanine (with sills separated by fluted pilasters), show a uniform treatment that seems to be highly disrupted due to commercial facilities.

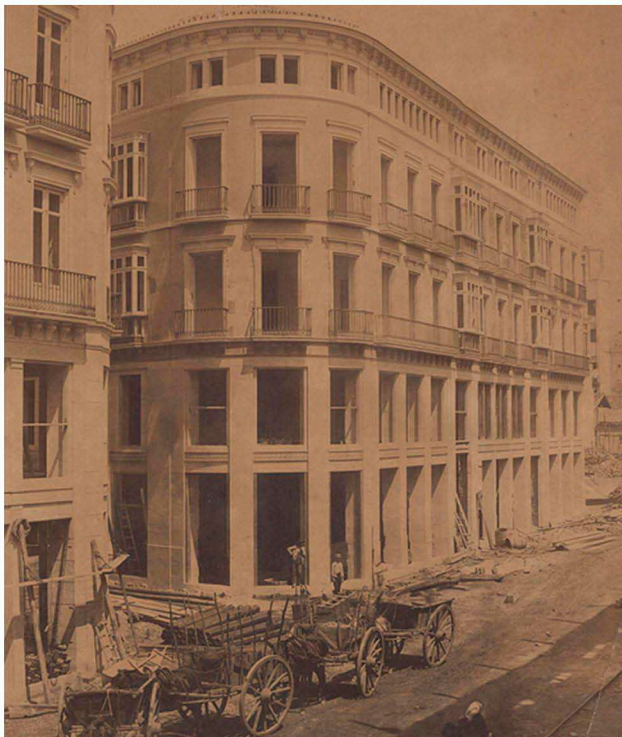
Figure 13. Building on 4 Marqués de Larios. 1889

The building located on 4 Marqués de Larios St. (see figure 13) preserves its character of unity with the rest of the other buildings in the same street, all of them designed by the same author.

The facade of the ground floor and the first floor shows sills separated by fluted pilasters, keeping a uniform treatment.

On the upper floors there seems to be a main central section flanked by symmetrical sides.

The cornice, on the other hand, is shown horizontally with imposts and a small corbel.

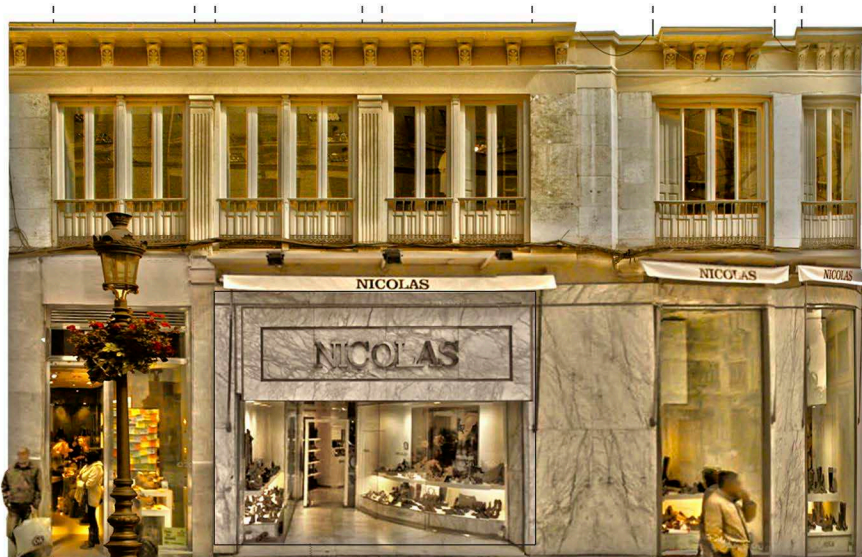
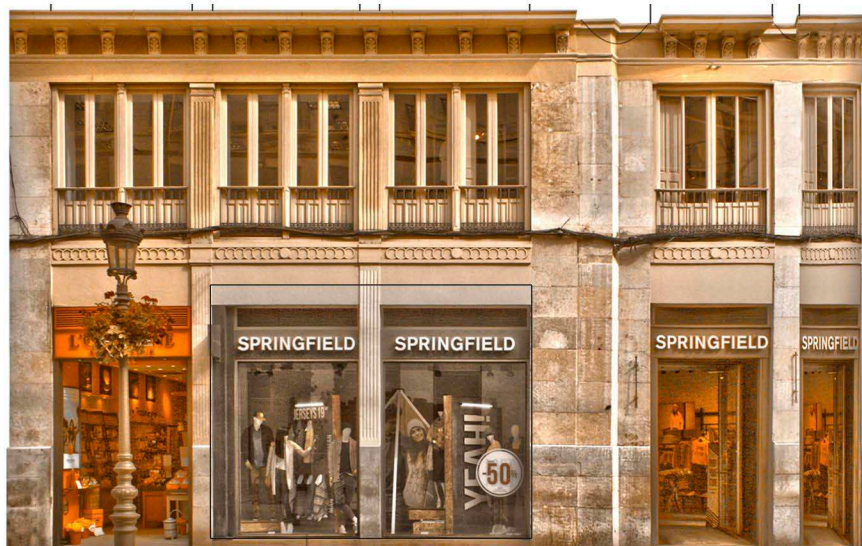
Figure 15. Original (Rhythms)

Figure 16. Delete (Nicolas)

Figure 14. Comparison of the restorations of Nicolas shop (1978-2012) and Springfield (2013-date).

If we compare both of the restoration projects applied to the same local shop, we can jump to the conclusion that there is a style unity. On the Nicolas's shoe shop facade, the entrance breaks the rhythm of it, the columns interfere with it, the awning covers the cornice, and the materials make the facade lose its homogeneity, until Springfield takes over, and takes all of these concepts back.
